Recommendation of inspection/replacement of hot parts in axial turbocharger

Reference: Service News TZ-S0002/TZ-S0198

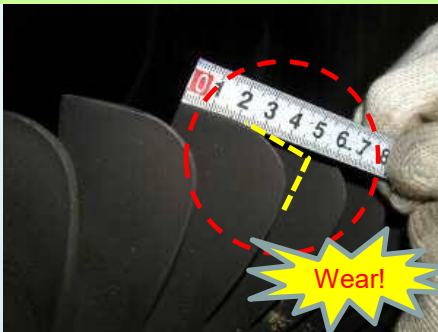
Turbine blade

Aged deterioration of hot parts is observed frequently around 10 years of use period. This deterioration will become a contributing factor of degradation of turbocharger performance, causing increasing of engine fuel cost and exhaust temperature high.

(Yellow broken line shows original shape of blade.)

Recommendation ~ Inspection and parts replacement during overhaul ~

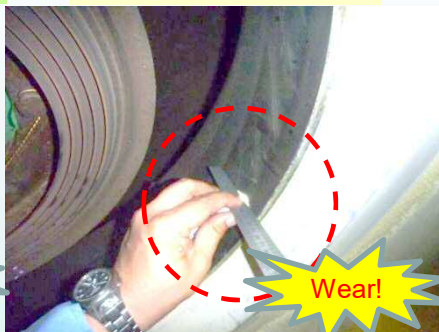
Gas outlet guide

(Occurrence of local wear)

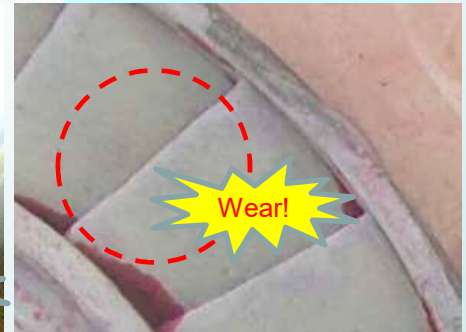
Nozzle ring

(Thickness of blade edge is decreased.)

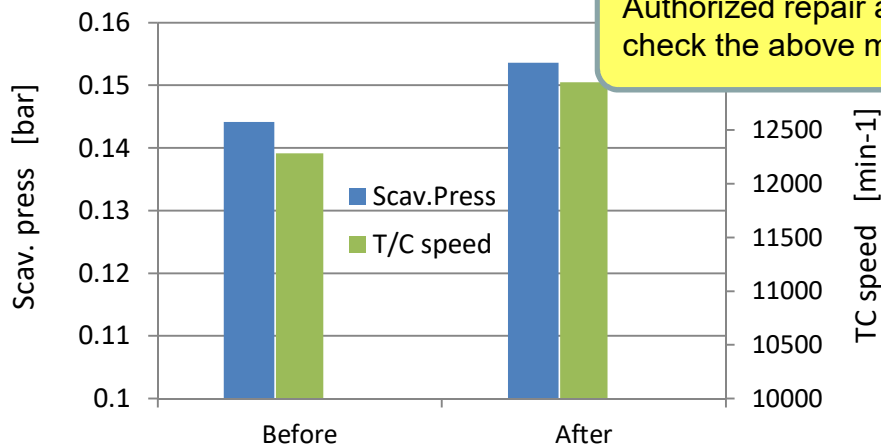
Case of MET53SEII / gas outlet guide-replacement

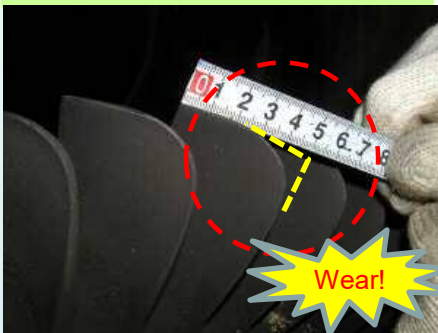
- ・ ホットパーツは概ね使用期間10年前後で経年的劣化が多くみられるようになります。この劣化は過給機性能、ひいては機関燃費悪化/排気温度高の一要因となります。

タービン翼
(黄色破線は元々の翼の形状)

推奨内容～オーバーホール時の点検並びに部品交換～

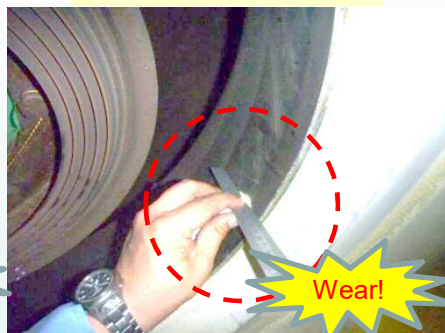
ガス出口案内筒
(局所摩耗の発生)

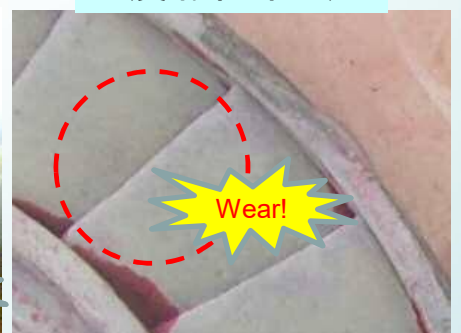
ノズル
(翼端部が細る)

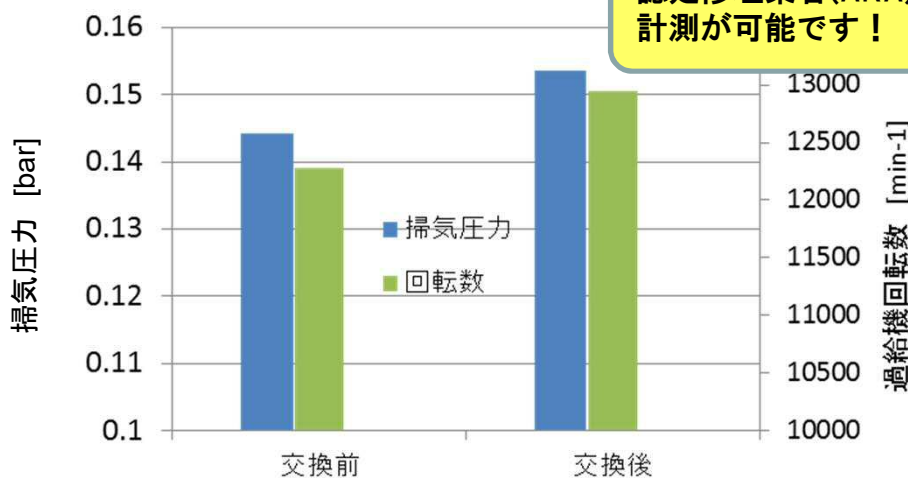
MET53SEIIIにおけるガス出口案内筒交換の実例
